Mod: IND-2F35/DH

IND-2F35/DH

TECHNICAL FEATURES

AFTER SALES SERVICE DATA

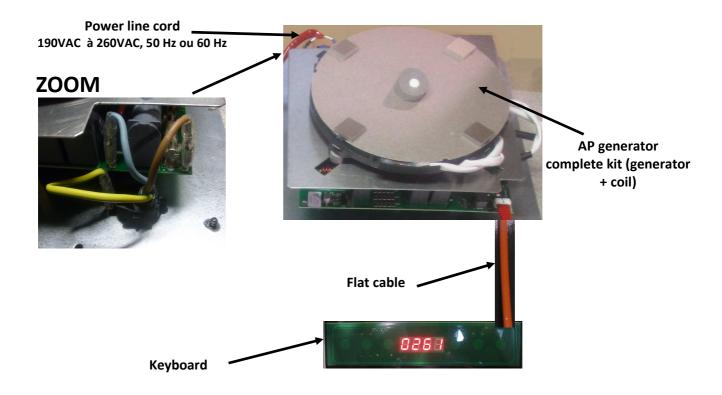
INTERCONNECTION:

HOW TO DISCONNECT THE CONNECTIONS INSIDE PRODUCT:

- 1 Be sure that the unit is disconnected of the main line
- 2 Open the vitroceram top casing
- 3 Disconnect the keyboard with precaution. It is necessary to hold the connector of the flat cable with 2 fingers. You should not remove directly the flat cable.
- 4 During the reassembly, It is necessary to be sure of the good connection of the keyboard and also of the good connection of the power cord sockets.
